Application Guide

UTILITY BOILERS - OIL/GAS FIRED

Application Note

Heat Recovery Steam Generators (HRSG)

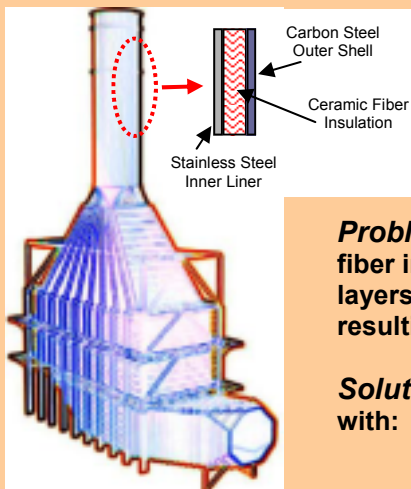
Problem—Deterioration of ceramic fiber insulation between steel liner layers in the exhaust gas stack resulting in shell hot spots.

Solution—Insulation injection repair with:

Plistix Injectite 2300
Pligun Verilite (pumped)
